FALL 1

This hall sensor was sent to us for repair / overhaul.

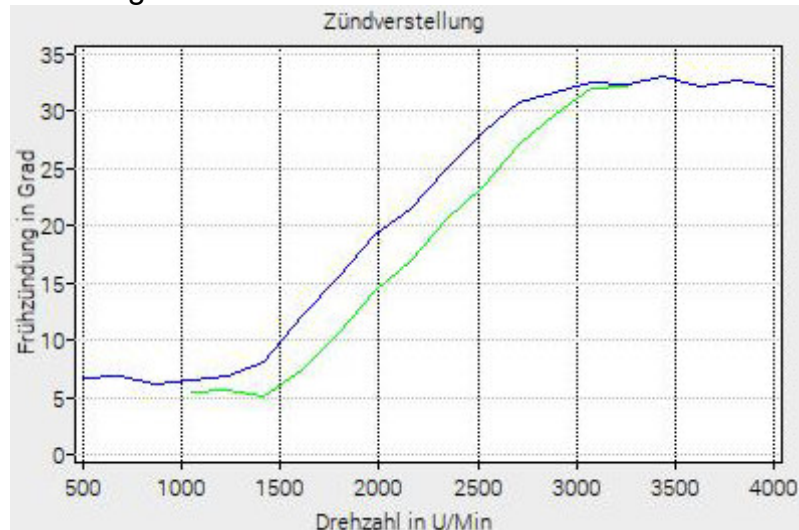
The green line shows the TARGET curve generated by the electronic BMW Hall sensor. The blue line shows the measured ACTUAL curve of the customer's hall sensor.

It is easy to see that the ignition timing deviates in the range from 1500 to 2800 rpm and that ignition occurs too early.

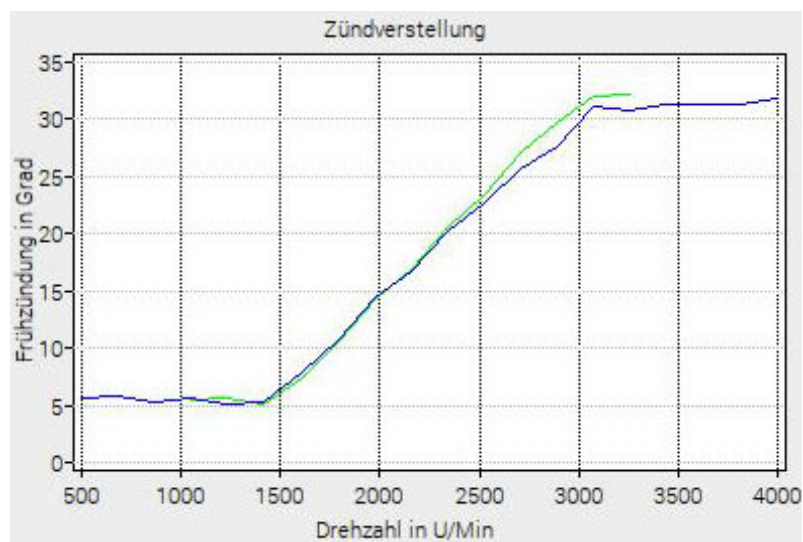
Conclusion: the engine runs quietly and smoothly again

After the overhaul, during which the selected matching springs were installed, this is the picture:
